Prevention solution for corrosion issues in CO₂ removal units in ammonia plants

Case Study Report

Doc. No: AKH01-STD-ENG-RPT-001

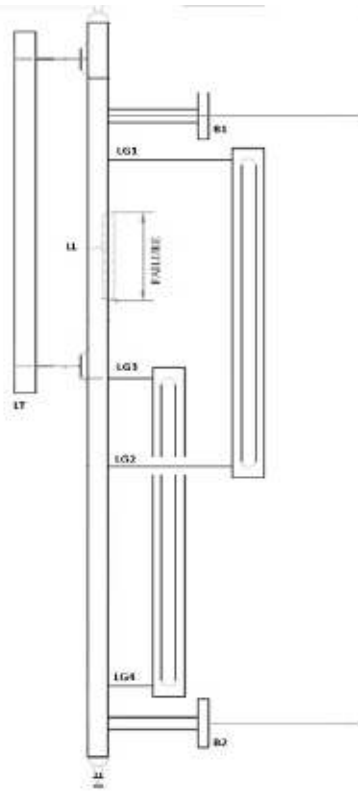
Figure 1. Level Bridle Arrangement

The bridle is made up of two nozzles attached to the tower (B1 & B2), four nipples attached to two separate level glasses (LG1, LG2, LG3 and LG4) and two further nipples attached to a level transmitter LT, all of which provides the level of Benfield solution within the absorption tower – Figure 1. The normal level during operation is as indicated in Fig. 1 (marked “L.L.”) and operating data for the level bridle pipe is given in Table 1.

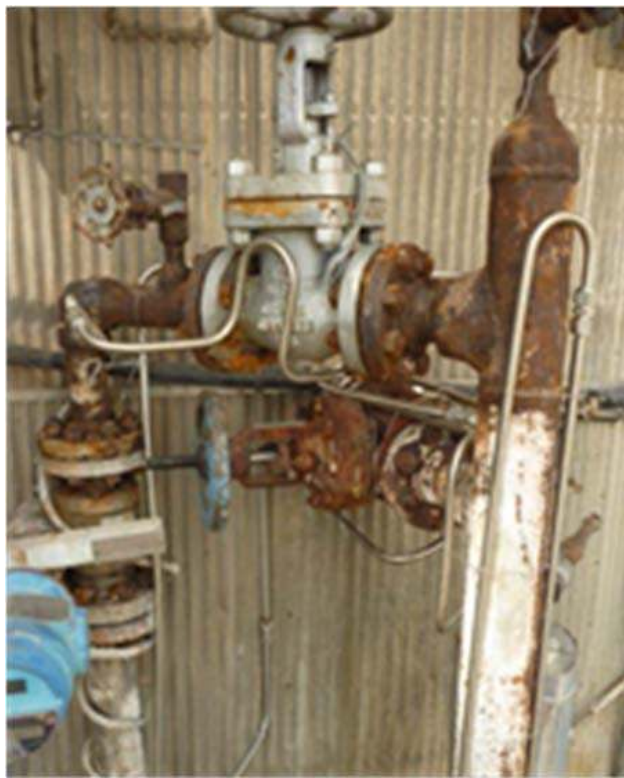
Figure 2. Failed level bridle

The failure occurred in the form of a sudden, total loss of containment with no previously identified leaks in the area. A section of the bridle was found to have peeled off. The failure took place directly in line with nozzle B1, approximately 1ft 3 inches below it. Upon inspection, immediately after the incident, vertical grooves emanating from the nozzle downwards were noted. There appears to have been some corrosive actions due to condensation of the Benfield vapour at nozzle B1 which continuously ran down the sides of the bridle wall. The appearance of the transverse part of the fracture surface is shown in Figure 4.

- Upgrade bridle chamber assembly at the next turnaround to stainless steel material, this way avoiding the complexity of not knowing if passivation takes place or not.
- In the corrosion study reviews, chambers and attachments to pressure equipment such as this should be classified as separate component for a better definition of the potential damage mechanisms according to the corrosion loop. As such it should also have its own detailed inspection plans.
- Review the passivation procedure for potential ‘dead leg’ areas in corrosive systems.
- Improve the process of draft inspection plan (outcome of RBMI) to the detailed equipment inspection plan to ensure nothing is taken for granted or not included.
- Regularly inspect the carbon steel bridle chamber installed until the next turnaround cycle.
- Review papers on condensation corrosion in ‘dead legs’.

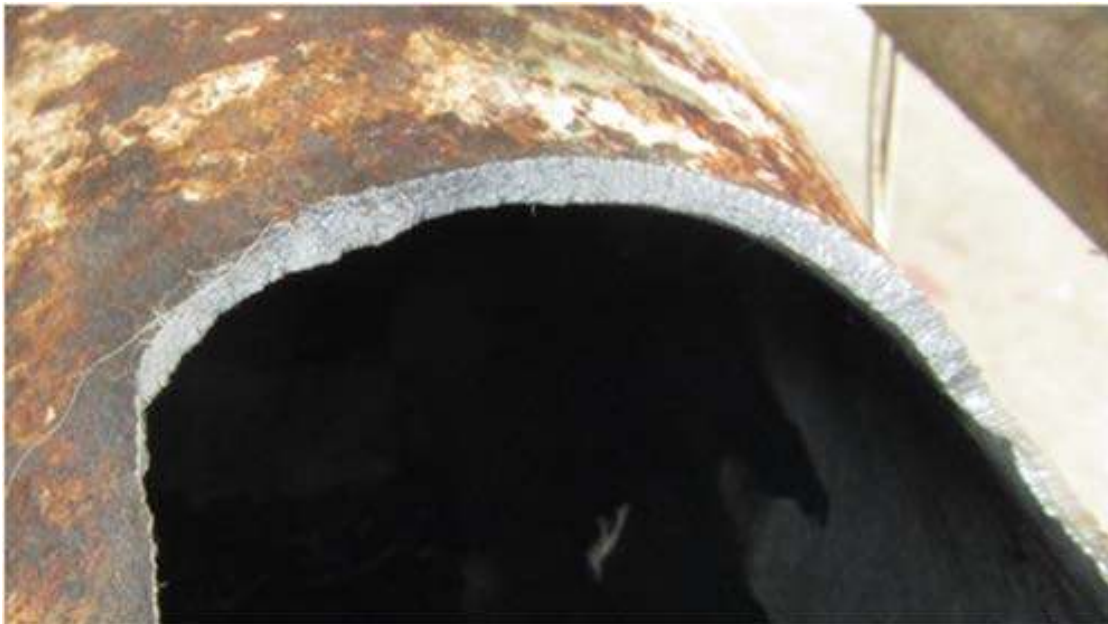
Figure 4. Traverse part of fracture surface

- The tube ruptured due to ductile overload in the result of localised thinning from internal surface corrosion.
- The source of corrosive liquid appears to be condensation of Benfield vapours at nozzle B1, which had continuously run down the bridle wall. The depth of the corrosion grooves tapered off as the general Benfield liquid level was reached.

- The appearance of the rupture indicated that the tube initially ruptured along two deep longitudinal corrosion grooves.
- The very narrow fracture surfaces on the longitudinal parts of the rupture showed that the bridle had suffered from severe local wall metal loss. The bridle wall thickness was less than 0.5 mm along parts of the deeper corrosion grooves. This thickness was below minimum required thickness to withstand the internal pressure of 400 psig (~28 bar) [3] and suggested that the rupture was initiated due to this reason (mechanical overload).
