UREA Case Study:

Addressing Safety Risks and Enhancing Reliability:

Overcoming Challenges with Tantalum Lining and Extended type Diaphragm Seal

Mr. Sander Posthumus
Dordrecht, 10 October 2024
Badotherm

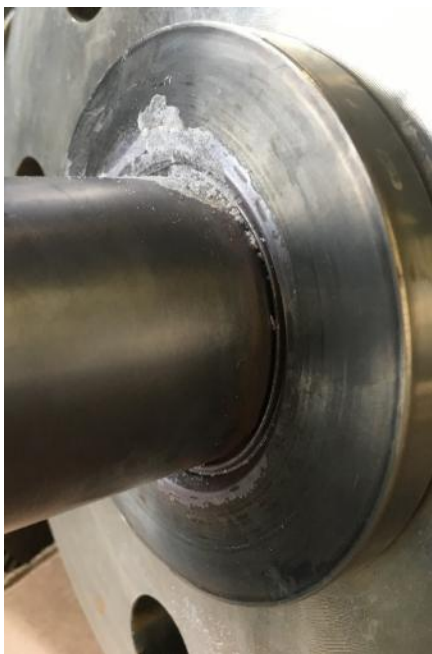
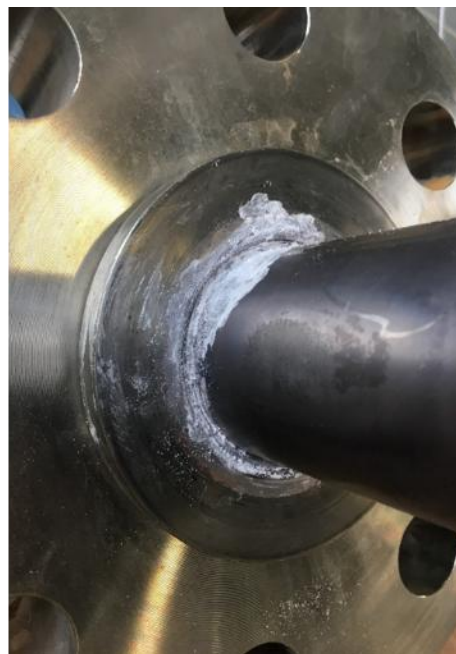
Within the high-pressure landscape of urea synthesis, an alarming incident unfolded, shedding light on the inherent risks associated with extended type diaphragm seals containing tantalum lining. See below picture of a typical extended type diaphragm seal construction.

Several pressure measurements and level measurements in the high pressure urea synthesis section were equipped with extended type diaphragm seals containing a tantalum lining. Although the diaphragm seal system was still working properly, the materials below the tantalum sleeve were subject to corrosion leading to a high risk of loss of product containment. The corrosive process medium was protruding under the tantalum sleeve to the diaphragm seal body made of AISI 316 and the gasket area was heavily deformed and corroding where the tantalum sleeve was welded to the body. And the weld of the lining to the body at the angle between extension and body was heavily corroded.

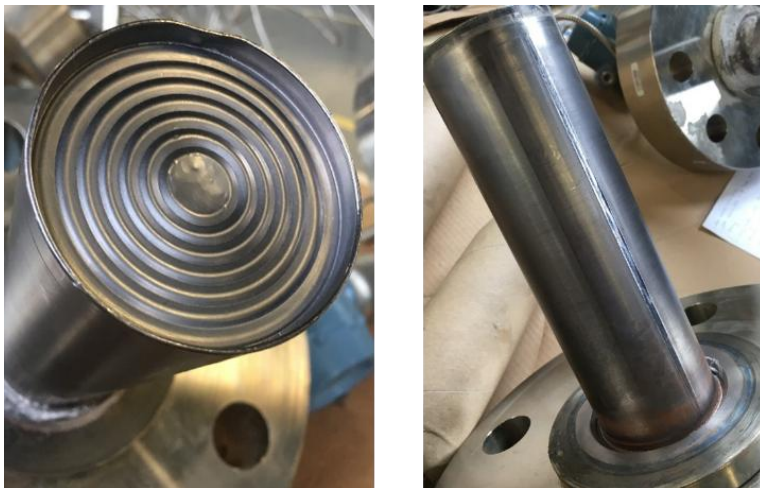
Overview 2: Particles Behind the Tantalum Sleeve

In these images, we observe particles that have made their way behind the tantalum sleeve. These particles likely entered from the gasket area and travelled towards the diaphragm. Their presence not only hampers measurement accuracy but also increases the risk of corrosion from within the sleeve.

To mitigate the earlier described risks and ensure long-lasting, robust performance, our company recommends the use of extended type diaphragm seals with no dissimilar welded. Hence we propose full body zirconium or Safurex® diaphragm seal systems. Unlike tantalum sleeves, the full body zirconium solution offered by Badotherm proves highly reliability. These diaphragm seals have been known to operate seamlessly for over 5 years without issues. During major plant shutdowns, if the diaphragm is undamaged upon careful disassembly, it can be inspected, calibrated, and reused. In case of diaphragm damage, a full refurbishment can be performed, reusing the zirconium body and cover flange while replacing the filling and diaphragm, resulting in substantial cost savings.

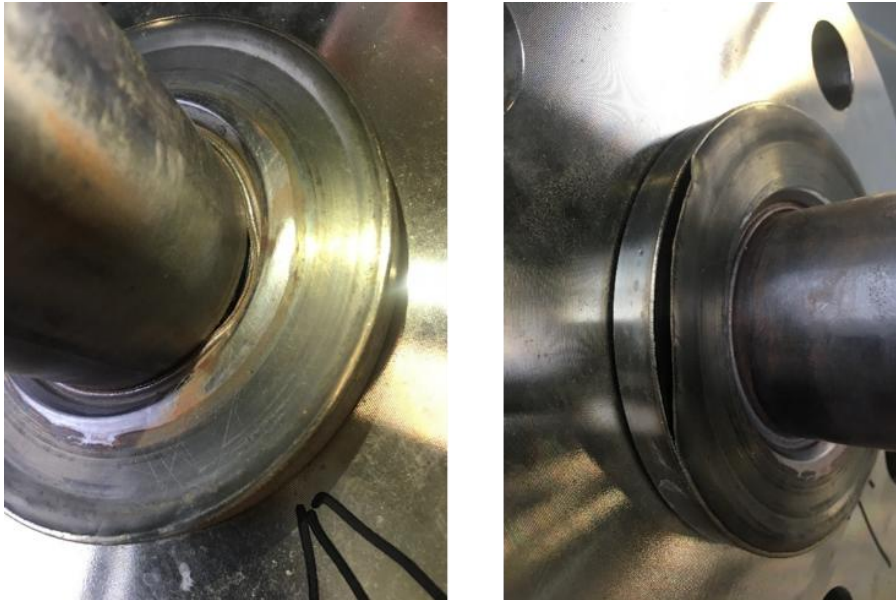
Overview 3: Heavy Deformation of Tantalum Lining and Loss of Adhesion

The third picture highlights the alarming deformation of the tantalum lining, particularly in the gasket area. The extensive deformation raises concerns about the diaphragm seal's integrity and performance. Moreover, the outer portion of the lining shows signs of detachment, indicating further potential vulnerabilities.
